Plett Botanical Estate, Erf 8010, Plettenberg Bay, Western Cape.

Specialist Aquatic Biodiversity Assessment

Prepared For: Hilland Environmental
Author: Dr. J.M. Dabrowski (PhD)
Confluent Environmental Pty (Ltd)
7 St. Johns Street,
Dormehlsdrift,
George, 6529
SACNASP: Pr. Sci. Nat. (Water Resources) – 114084
Date: 4 April 2026
Version: Draft Final

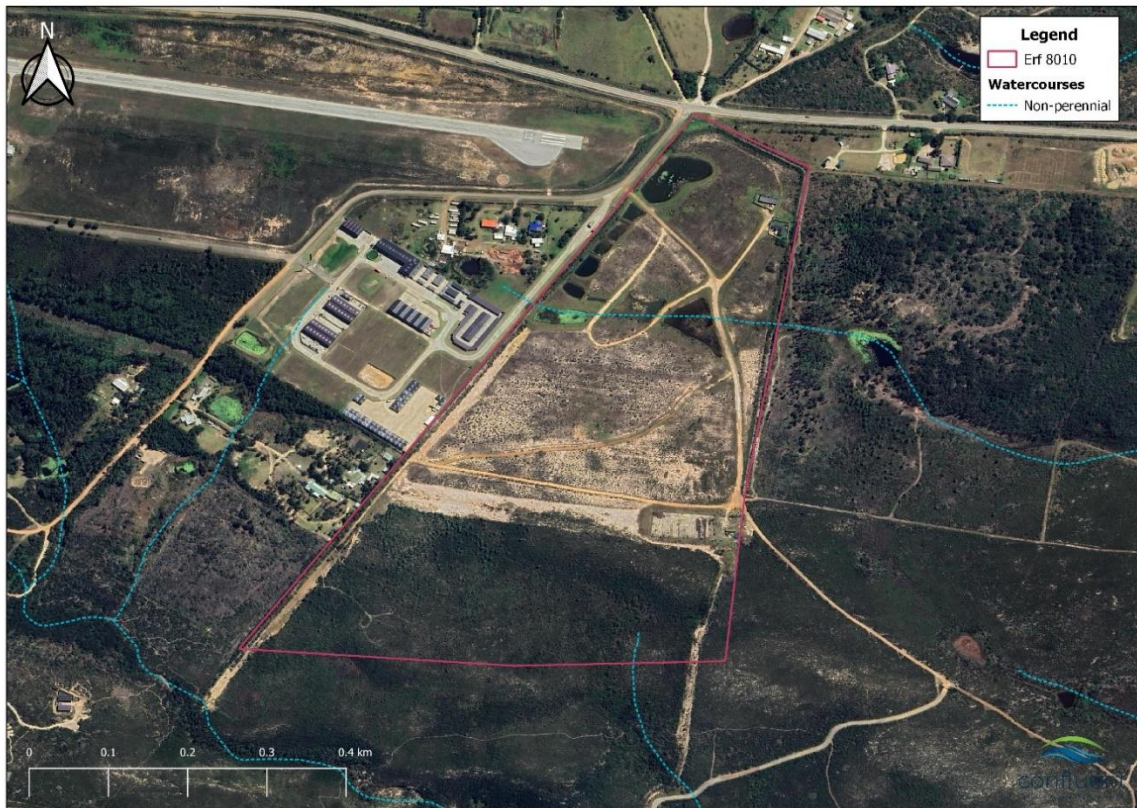
The site falls within Primary Catchment K (Kromme) area and in Quaternary Catchment K60G (Figure 2). According to geospatial data sources, two non-perennial streams run through the property (Figure 3). The northern watercourse originates from the property to the west, flows through the northern third of Erf 8010 and into the neighbouring property on east. Another watercourse flows in a southerly direction, exiting the southern boundary of Erf 8010, before joining a perennial watercourse running through the neighbouring property to the south. A series of small dams have been created along the western boundary of the property and along the mapped northern non-perennial watercourse (Figure 3).

Figure 3: Map showing watercourses mapped on the property.

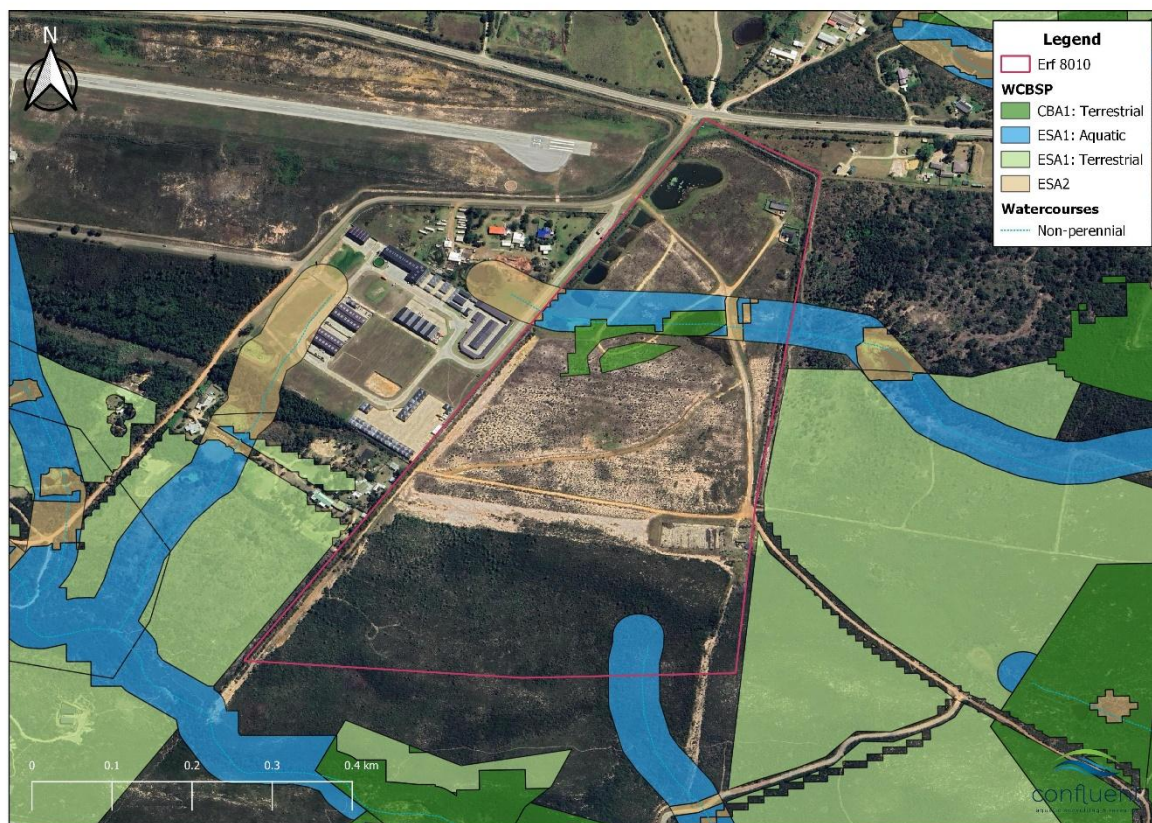
Figure 5: Map of Erf 8010 relative to the Western Cape Biodiversity Spatial Plan.

According to the WCBSP for Bitou, no aquatic CBAs are indicated to occur with Erf 8010. The mapped non-perennial watercourses have been categorized as aquatic Ecological Support Areas (ESAs - Figure 5), which are relatively unimpacted aquatic features that are not considered important for meeting biodiversity targets, but are important for providing important supporting functions (Table 1). In this particular case, the streams have been identified as important water source areas. The management objective of ESAs is described in Table 1, which is to maintain in a functional near natural state, ensuring that the continued provision of ecological support services is not compromised.

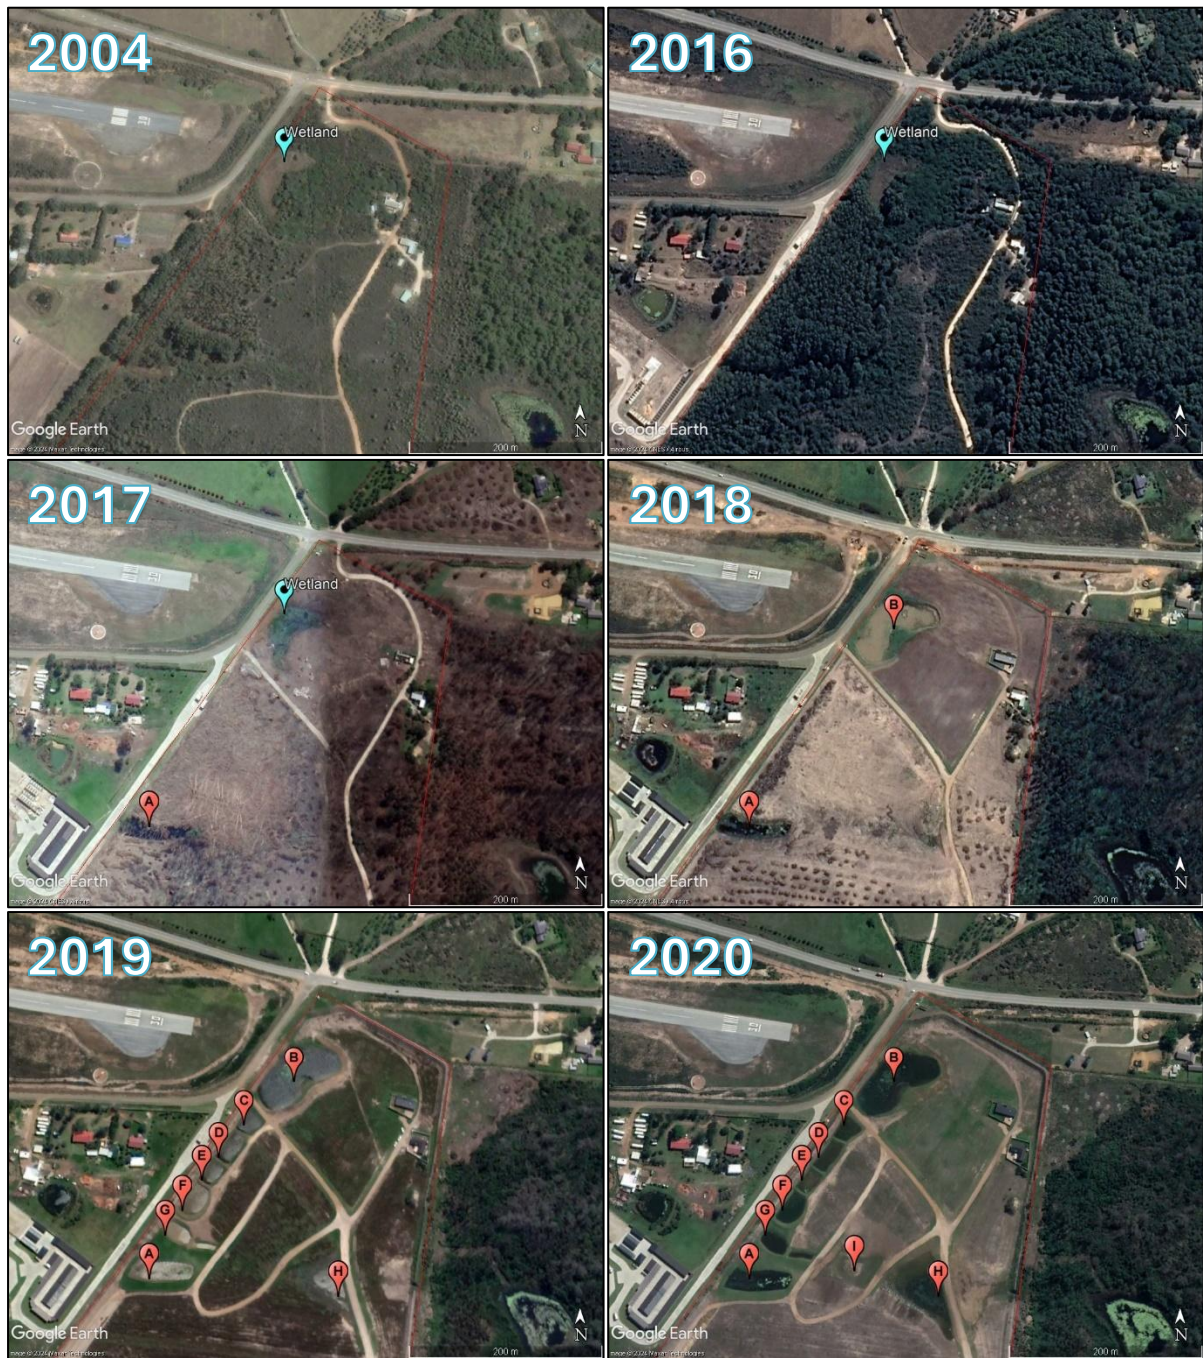
- 2017: Clearance of vegetation on the site in 2017, revealed the presence of a small dam (A) along the western boundary. The presence of the depression wetland is clearly visible against the surrounding cleared vegetation. The deep green colour of the wetland vegetation (indicative of wet conditions) contrasts with the brown colour of the vegetation (indicative of drier conditions) as observed in the 2004 and 2016 image and indicates that the wetland experiences seasonal periods of inundation.

- 2020: An additional dam (I) was constructed in between Dam A and H.

Figure 6: Google Earth imagery indicating the progression of the construction of dams on the property.

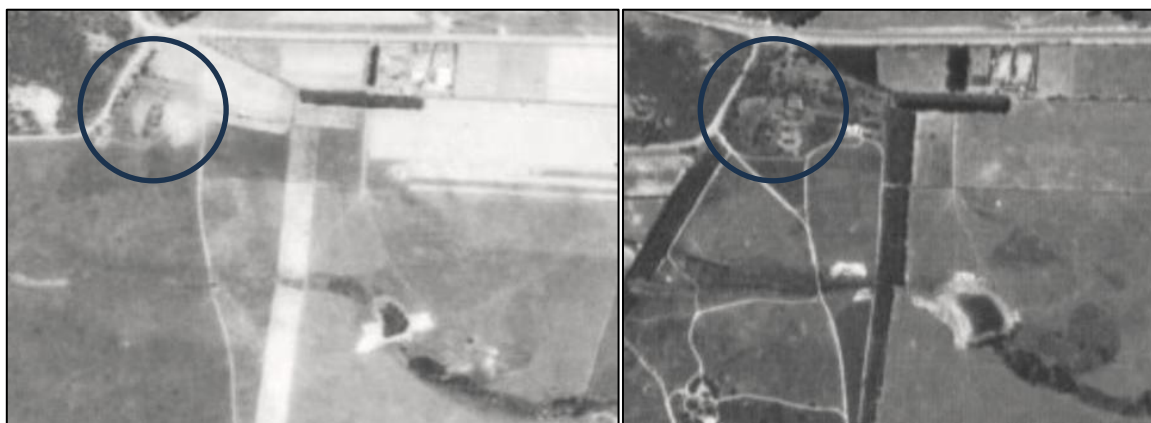
With respect to the depression wetland, historical imagery indicates the presence of the wetland as far back as 1958 (Figure 7). These images also indicate the likely presence of a small watercourse that drains into a small dam to the east of the property.

Figure 7: Historical aerial photographs indicating the presence of the depression wetland in 1958 (left) and 1972 (right).

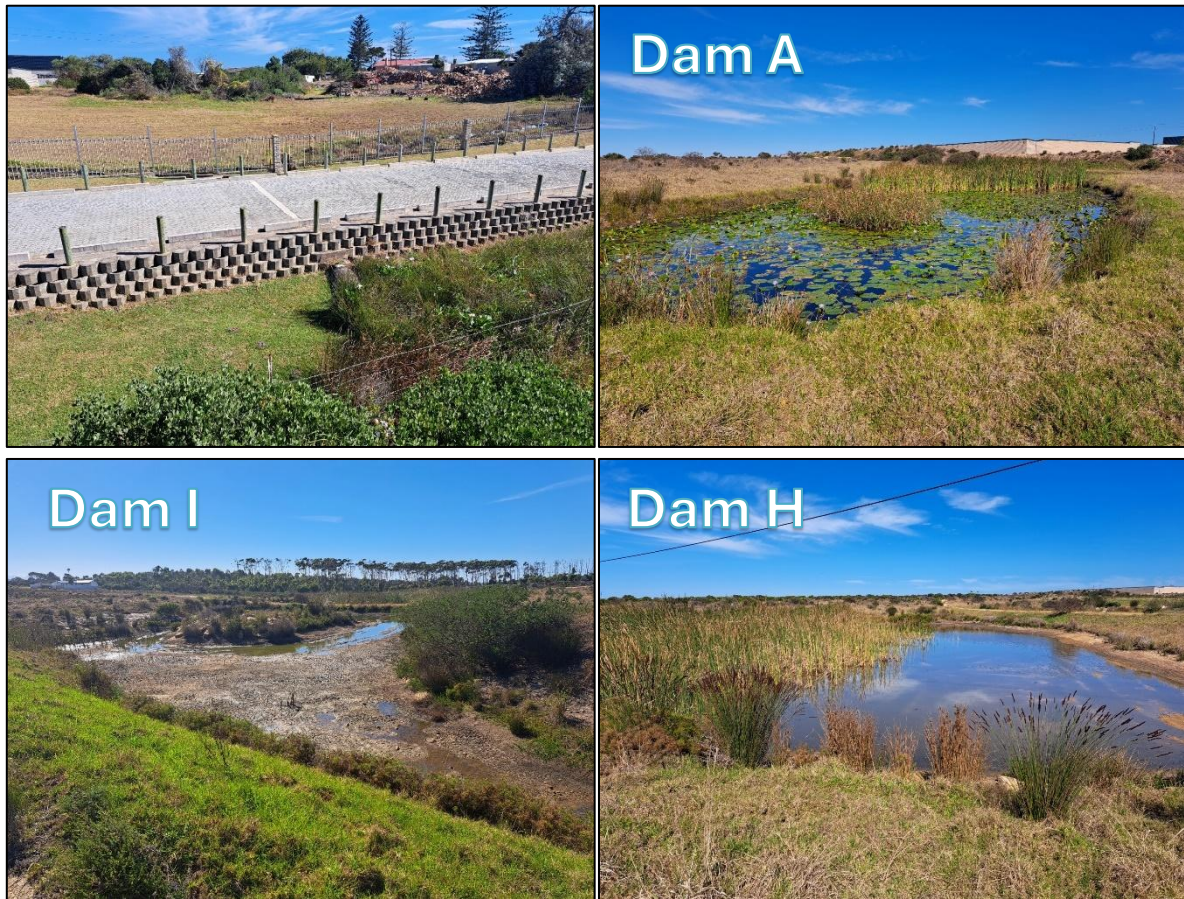
Figure 8: View to the west of Dam A, showing the road adjacent to the property. A stormwater channel is visible to the west of the road as well as a 600 mm pipe which discharges water from the channel into Dam A (top left); Dam A; Dam I; and Dam H.

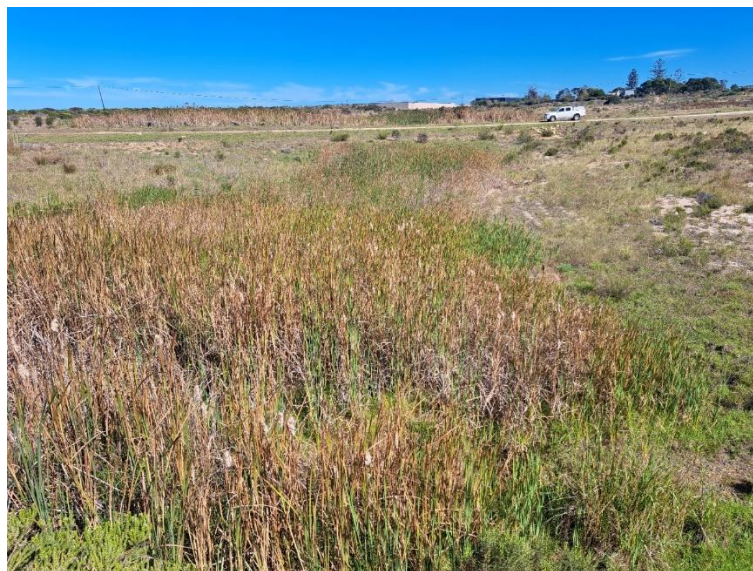
Figure 9: View of the artificial wetland area created below Dam H.

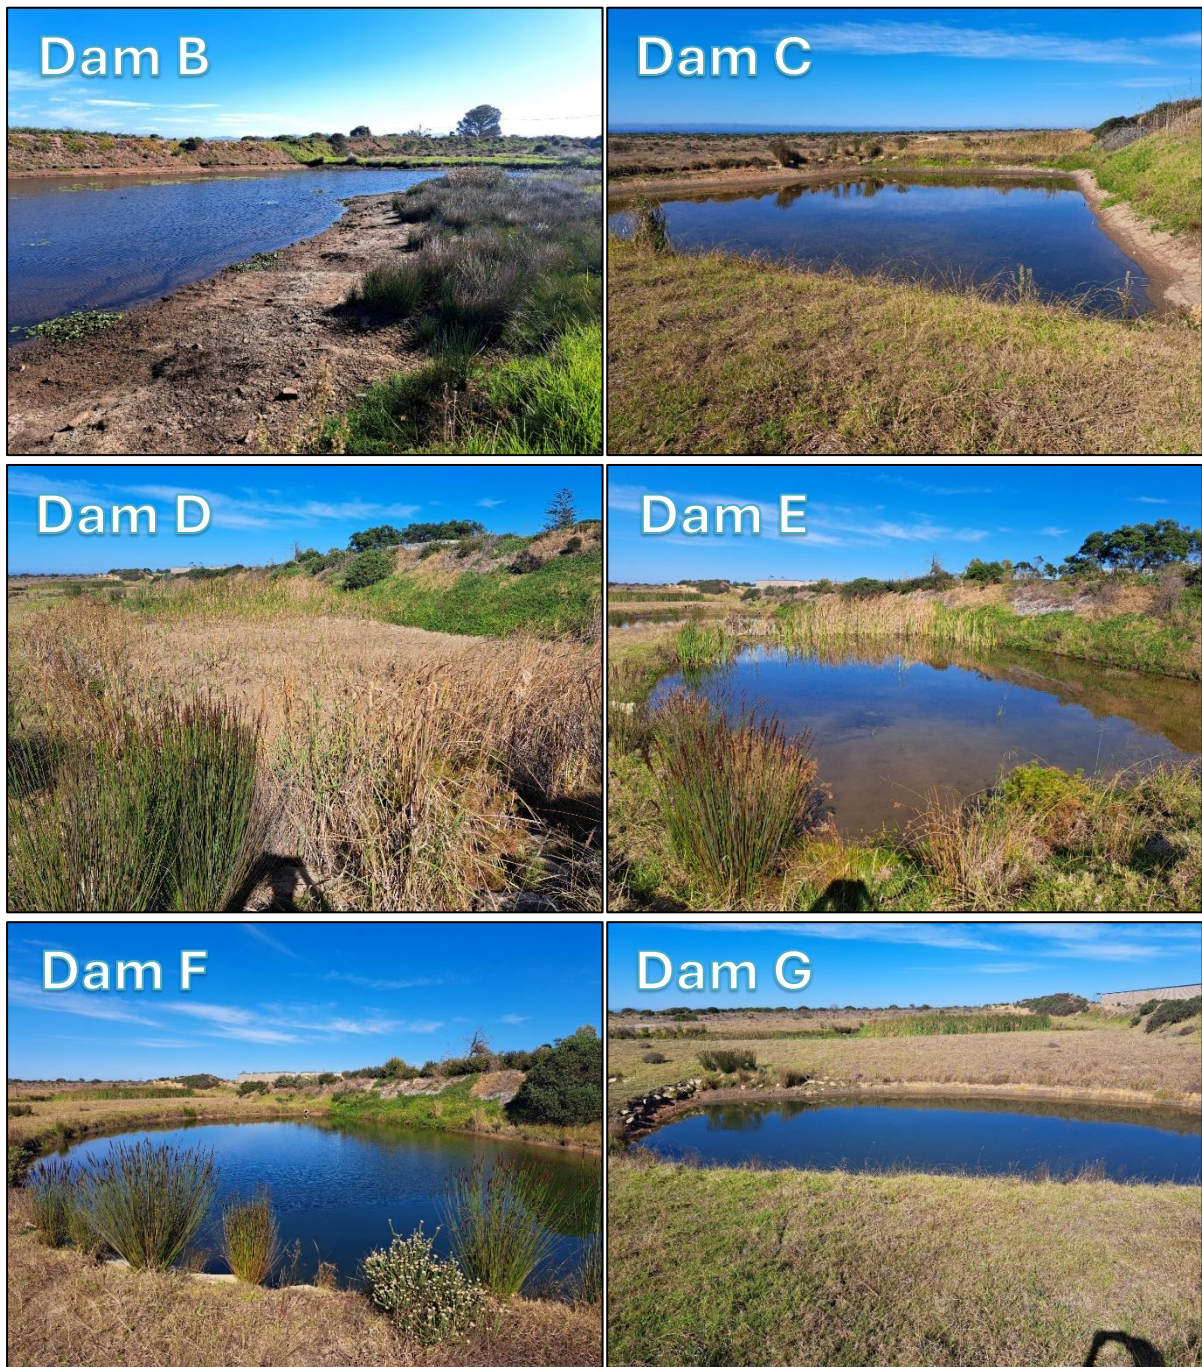
Dam B also received stormwater via a formalised culvert that drains the road and a large portion of the airport runway to the west. When filled, Dam B overflowed into Dam C to Dam G via pipes that connect the dams (Figure 10). While these dams were relatively low at the time of the site visit, historical imagery indicates that they are frequently full of water and provided habitat for a variety of bird species and other aquatic organisms. The ecological condition of the wetland prior to the establishment of Dam B cannot be verified with any certainty. Historical imagery does indicate the presence of what appears to be a depression wetland from as far back as 1958. More recent imagery indicates that the wetland received stormwater from the existing culvert prior to its excavation in 2018, which undoubtedly played a role in sustaining the wetland area. Given that Dam B sustained water levels in Dams C to G, it was evident that the wetland would have received substantial volumes of stormwater. Satellite imagery indicates that the dam was covered by vegetation throughout its extent and was most likely seasonally inundated following periods of high rainfall. A soil berm has been created around the perimeter of the property – presumably from material excavated out from each of the dams and from historical clearance of the site.

Figure 10: Photographs of Dams B to G.

- Dam B was most likely a natural depression wetland prior. As the site was not visited prior to the construction of the dam, it is not possible to verify the ecological condition of the wetland before it was transformed. Historical imagery suggests that the wetland was vegetated throughout its extent and experienced seasonal periods of inundation. The sensitivity of the wetland is considered to have been **Very High**. Rehabilitation of the wetland is recommended.

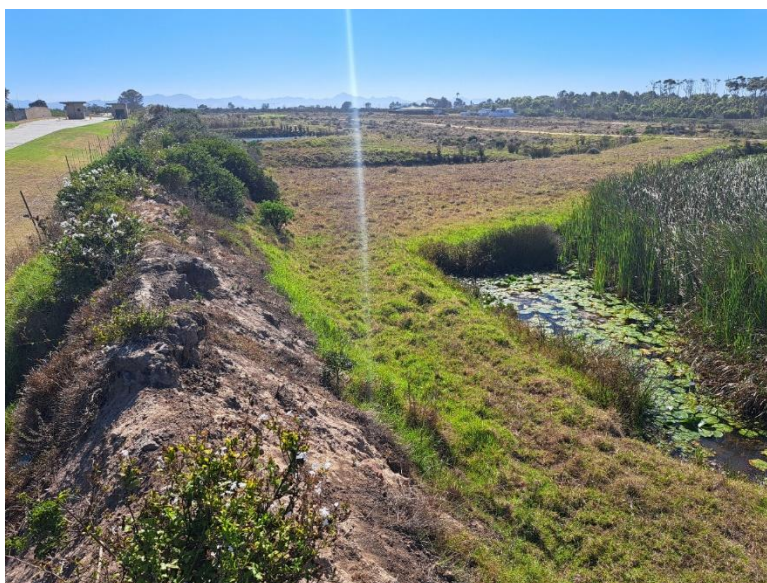
Figure 11: Photograph illustration the soil berm running along the perimeter of the property.

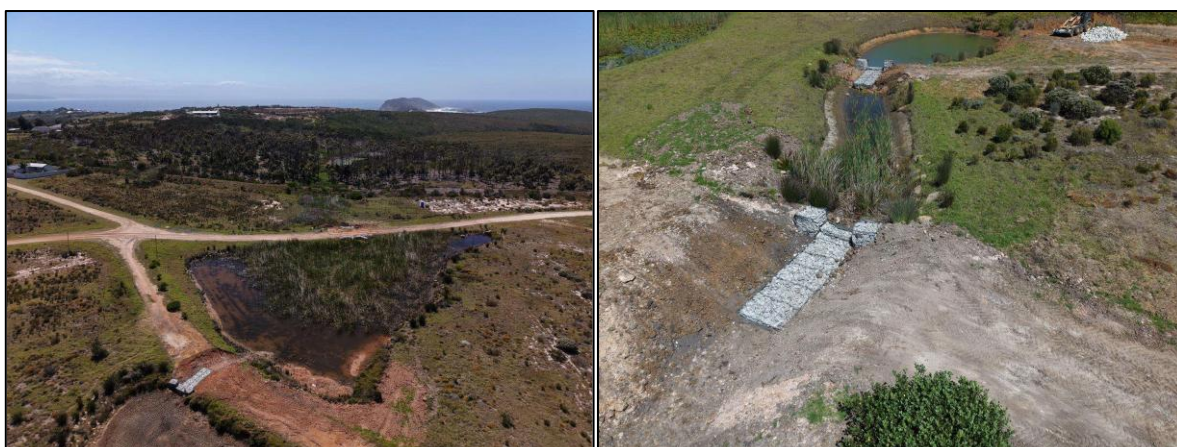
Subsequent to the original site visit it was determined that all of the above-mentioned dams had been constructed without the requisite authorisation from the Breede Olifants Catchment Management Agency (BOCMA). A pre-directive issued to the applicant required that these dams had to be removed and that Dam B should be rehabilitated to restore the former wetland characteristics. Since the original site visit all dams have subsequently been removed, allowing free flow of water through the property (Figure 12). Gabion structures have been incorporated into the drainage to dissipate stormwater energy along the drainage. The former

basins of the dam will serve as stormwater attenuation basins, releasing stormwater in a controlled manner to downstream habitats.

Figure 12: Photographs showing dam walls excavated out with gabion flow energy dissipation structures.

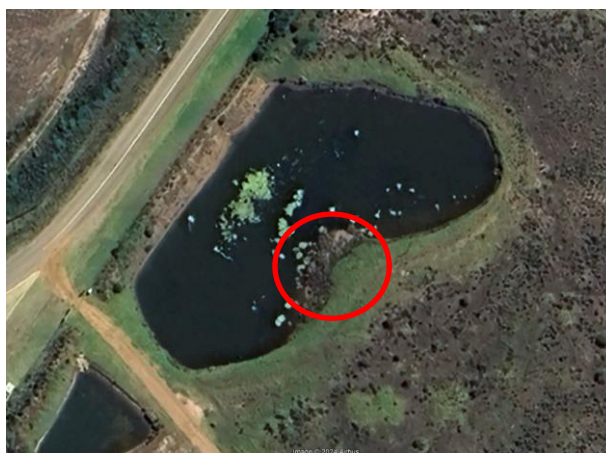
Figure 13: Current stand of wetland vegetation which must be demarcated and left undisturbed.

- No rocks, rubble or building material may be used to fill in the wetland;
- The patch of wetland vegetation along the eastern edge of the wetland (Figure 13) could serve as an important seedbank for passive revegetation of the wetland over time. This patch of vegetation must be demarcated and must not be disturbed during infilling and can be used as a reference to gauge the height of infilling required throughout the remaining area of the wetland.

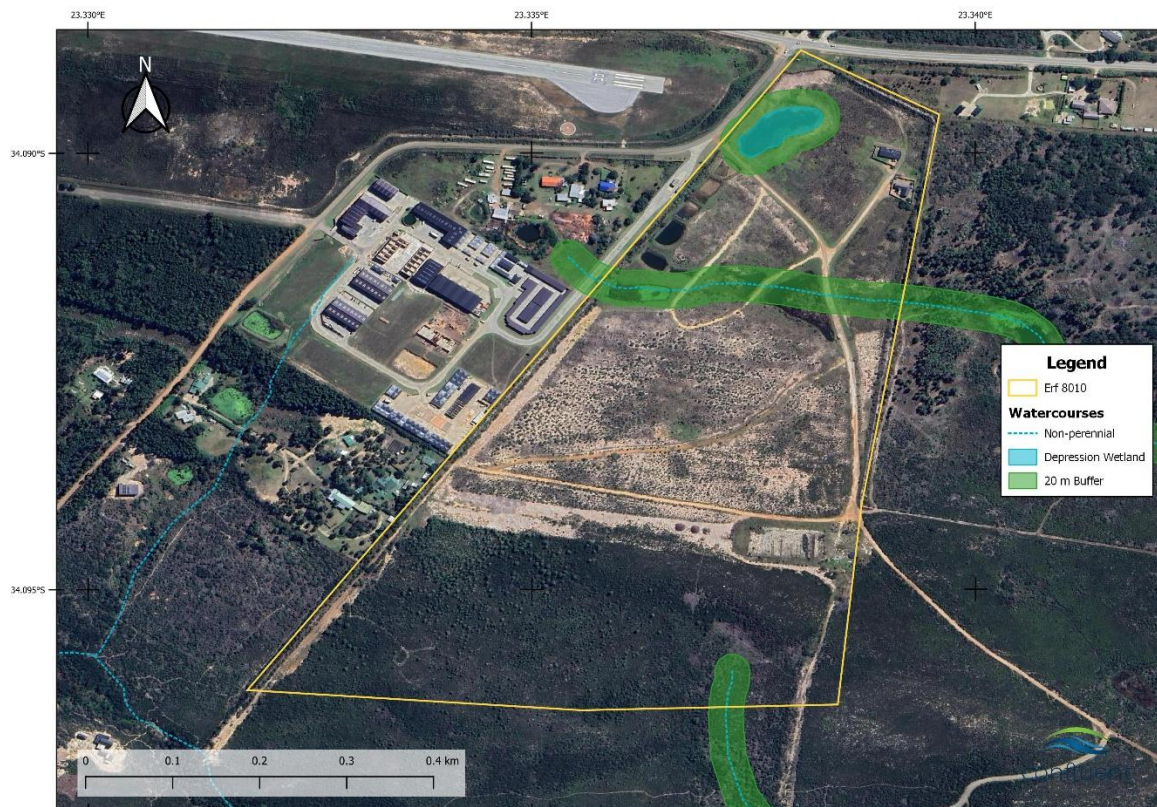
Parameter	Value
MAP	Up to 1000
Rainfall Intensity	70.9 – Zone 4 (Very High)
Soil SCS	A/B
Slope of Catchment	Gentle (2 – 10 %)
Slope of Buffer	Moderate (10 -20 %)
Soil erosion potential	0.74 (Very High)
Vegetation Characteristics	Fair
Soil Permeability	Low
Buffer Width	20 m

Figure 14: Map illustrating watercourses and recommended buffers
